28,000 Hour Xenon Hollow Cathode Life Test Results

Timothy R. Sarver-Verhey
NYMA, Inc., Brook Park, Ohio

Prepared for the
25th International Electric Propulsion Conference
sponsored by the Electric Rocket Propulsion Society
Cleveland, Ohio, August 24-28, 1997

National Aeronautics and
Space Administration

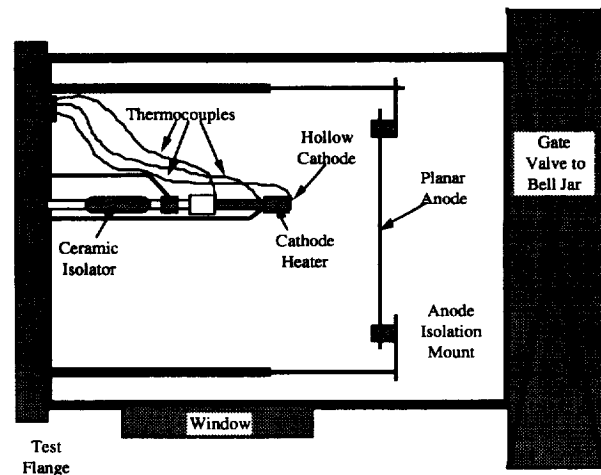
Figure 2. Schematic of life test configuration.

The life test was performed in a diode configuration with a planar anode mounted approximately 6 cm downstream of the hollow cathode (see Fig. 2). Information pertaining to test configuration, feed system design, power supplies, and instrumentation was provided in an earlier report.¹⁶

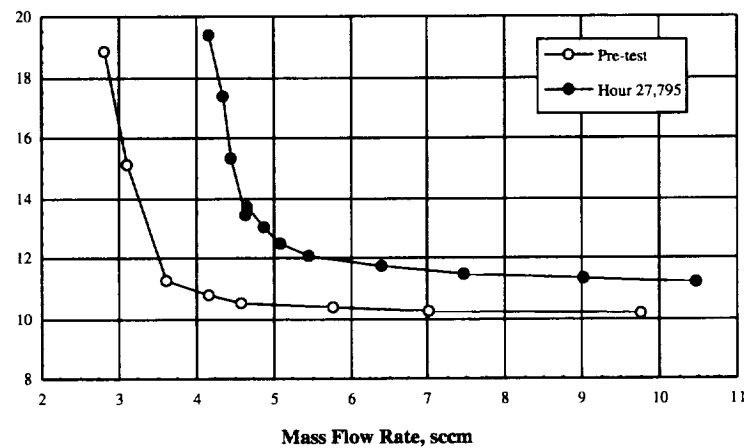
The hollow cathode was characterized repeatedly during the test by measuring the anode voltage and cathode temperatures under variation of xenon flow rate. The voltage and temperatures are the dependent operating parameters of the cathode and reflect changes in condition. Figure 3 shows the pre- and post-test behavior of the anode voltage as a function of the xenon flow rate at a fixed emission current of 12 A. At the start of the life test, the anode voltage increased rapidly at flow rates below approximately 3.6 sccm. By the end of the test, the anode voltage increased rapidly at flow rates below about 4.8 sccm. In addition, the anode voltages were higher at all flow rates. Characterizations performed during the test agreed with the trend shown in Fig. 3.

The nominal anode voltage at the life test flow rate increased by approximately 16% during the test. While this increase is indicative of changing cathode condition, it was within the bandwidth observed during previous HCA cathode life tests.¹¹ Additionally, the anode voltage during this life test was always significantly lower than the maximum allowable anode voltage of 40 V for the HCA.³ Consequently, voltage increases simi-

lar to that observed during this life test should have negligible impact on HCA operation.

Figure 3. Anode voltage vs. xenon flow rate before and after life test.

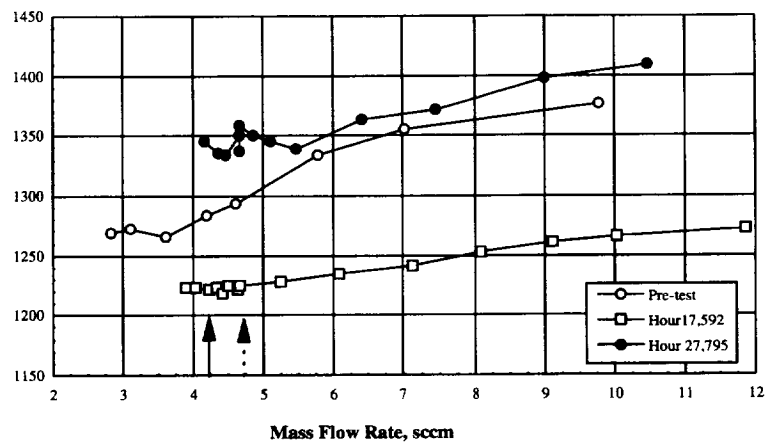
The effect of flow rate on cathode tip temperature over the course of the test is shown in Figure 4. The pre-test data and the data obtained at hour 27,795 exhibited comparable operating temperatures over much of the flow range. However, at the life test flow rate, the tip temperature increased by approximately 50 °C over the course of the test. This increase resulted in the hollow cathode operating near the cut-off temperature of 1,350 °C (DF pyrometer reading), which is discussed below.

Measurements taken during the life test up to the 23,776 hour mark were consistently and substantially lower than the pre-test and final temperature measurements over the entire flow range. This is illustrated in Fig. 4 by the data taken at hour 17,592. This data set was selected at random as a typical example of this behavior. After 23,776 hours, the tip temperatures below 4.6 sccm exceeded the pre-test values.

The cathode temperature exhibited the greatest sensitivity to xenon flow rate at the beginning of the life test. By the end of the life test, the cathode could not be operated below 4.2 sccm without the DC and AC components of the anode voltage rising significantly. The HCA flow rates were selected to ensure that the cathode does not operate near this region with significant DC and AC anode voltage components.³ Therefore, this effect is expected to be inconsequential for the ISS program.

Figure 4. Hollow cathode operating temperature vs. xenon flow rate. All data taken with a disappearing filament pyrometer at a fixed emission current of 12 A. The arrows indicate the life test flow rate set point (solid line - pre-test; dotted line - Hour 27,795).

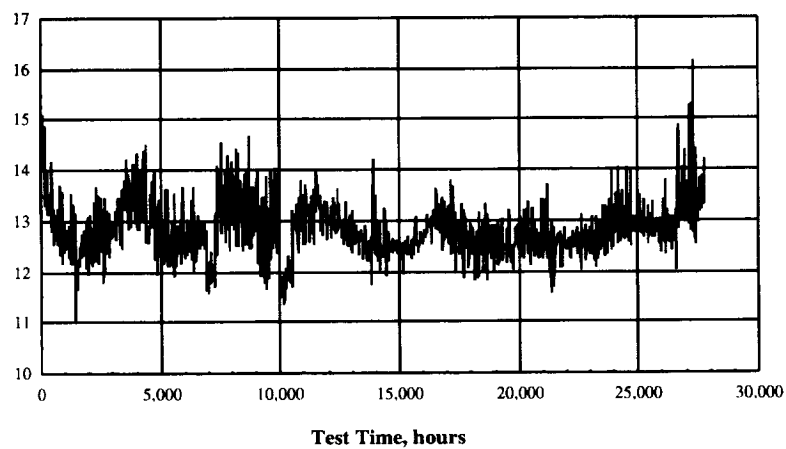
Hollow cathode performance during the life test was determined by monitoring the anode voltage and cathode temperatures. Figure 5 shows the behavior of the anode voltage as a function of test time. Two types of voltage variations were observed. First, the anode voltage varied over a period of several thousand hours with a mean value of 12.9 V. The range of this voltage variation is listed in Table 1.

Second, nominal daily voltage variations of approximately ± 0.3 V resulted from changes in xenon flow rate caused by ambient laboratory temperature changes. This variation appears as the noise on the anode voltage measurement in Fig. 5. The corresponding flow rate changes were typically ± 0.2 sccm.

Figure 5. Anode voltage vs. test time.

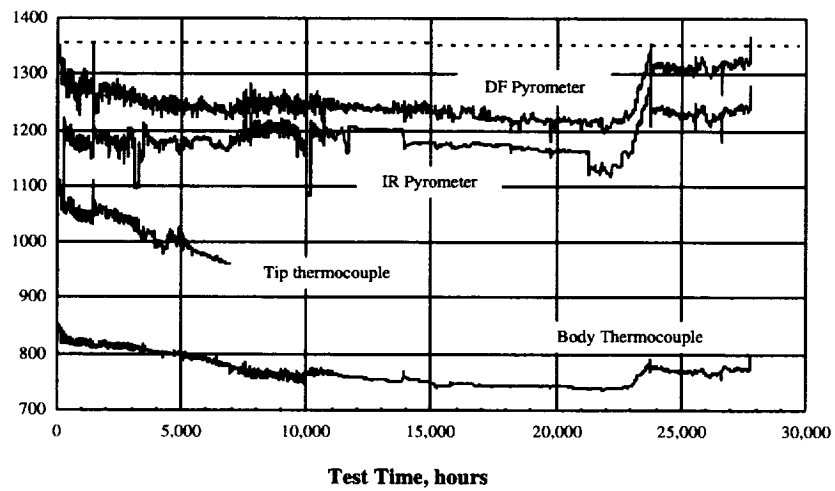
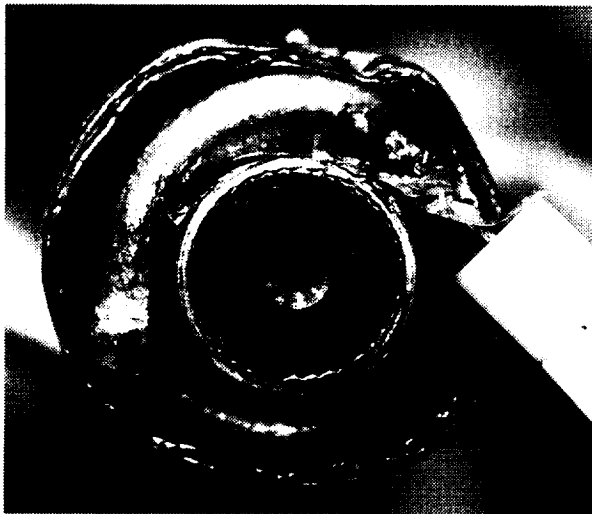
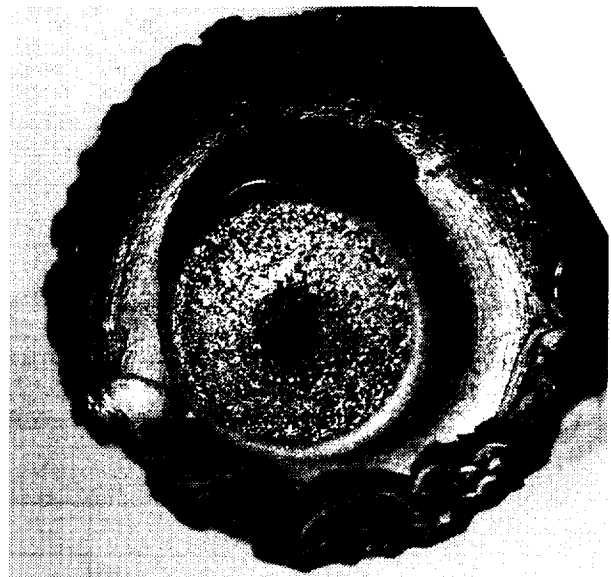
The physical conditions of the hollow cathode and electron emitter are presently being evaluated. The pre- and post-test conditions of the hollow cathode are shown in Figure 7. Preliminary results indicate that the cathode orifice was generally in good shape and increased in diameter by approximately 14%. This change is believed to be sufficient to cause the shift in cathode operation shown in Fig. 3.

In addition, the orifice plate and cathode exterior surfaces were textured by ion bombardment, though the erosion was not sufficient to remove surface features (i.e. orifice plate weld structure, orifice chamfer, sheathed heater surface).

Finally, the sheathed heater radiation shielding was found to be severely eroded, with the exposed surfaces exhibiting degradation. This erosion is attributed to ion bombardment due to operating the cathode with a planar anode that resulted in significant exposure of the

heater radiation foil to the discharge plasma. This degradation is significant for this life test because it is suspected to have degraded heater capability. However, the HCA cathode does not experience similar degradation due to its configuration.¹¹ Destructive examination of the life test cathode is on-going.

Figure 7. End view of the life test hollow cathode. (a) Pre-test. (b) Post-test.
